Present status of Gottigere Tank : Indicator of Decision maker's apathy

Ramachandra T.V , Sudhira H.S.

ENERGY AND WETLANDS RESEARCH GROUP
CENTRE FOR ECOLOGICAL SCIENCES
INDIAN INSTITUTE OF SCIENCE
BANGALORE 560 012

ENVIS Technical Report : 26

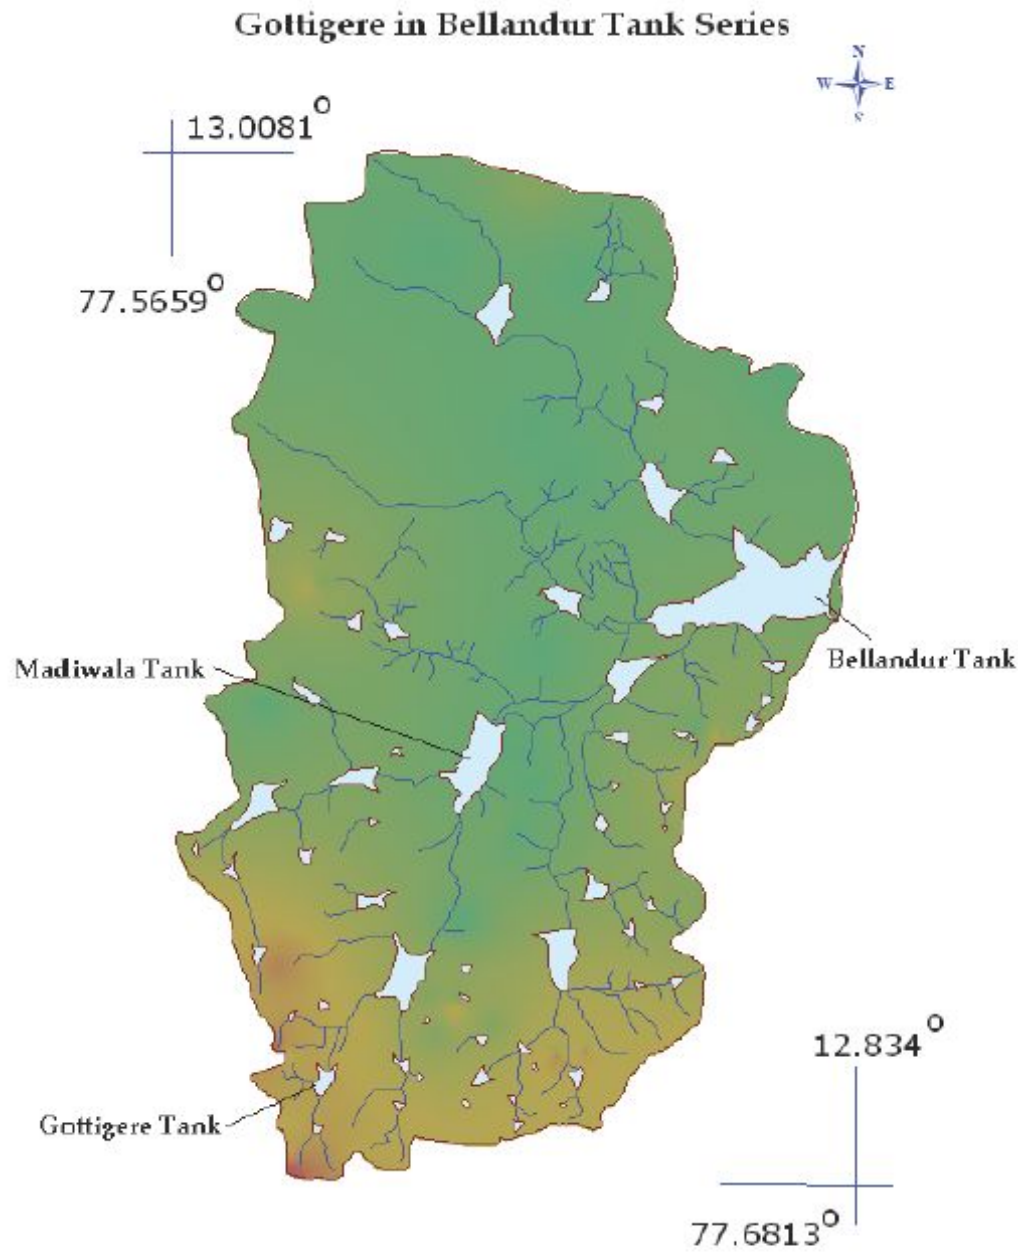
Figure 2: Gottigere Tank in Bellandur Tank Series

The Gottigere tank is part of the South Pennar river basin and is an important feeder tank to the Hulimavu and Madiwala tanks, which eventually feed to Bellandur and Varthur tanks. It has a water-spread area of 14.98 Ha. The location of the tank in the Bellandur tank series is depicted in Figure 1 and Figure 2, which gives a panoramic overview of the tank and the tank in Bellandur watershed. The rainfall data for the region is available for the last 100 to 110 years. Rainfall varies from 725.5 mm to 844.8 mm. The district receives 51 % of the total annual rainfall in the southwest monsoon period, i.e. June to September. The average annual rainfall in the catchment was 859 mm in 1999. April is usually the hottest month with the mean daily maximum and minimum temperature of 33.4° C and 21.2° C respectively. December is generally the coolest month with the mean daily maximum and minimum temperature of 25° C and 15.3° C respectively. The temperature drops down to 8° C during January nights. Relative humidity is high from June to October (80 to 85 %). Thereafter, it decreases and from February to April becomes 25 to 35%. The relative humidity in the morning is higher than in the evening, giving rise to the formation of fog.

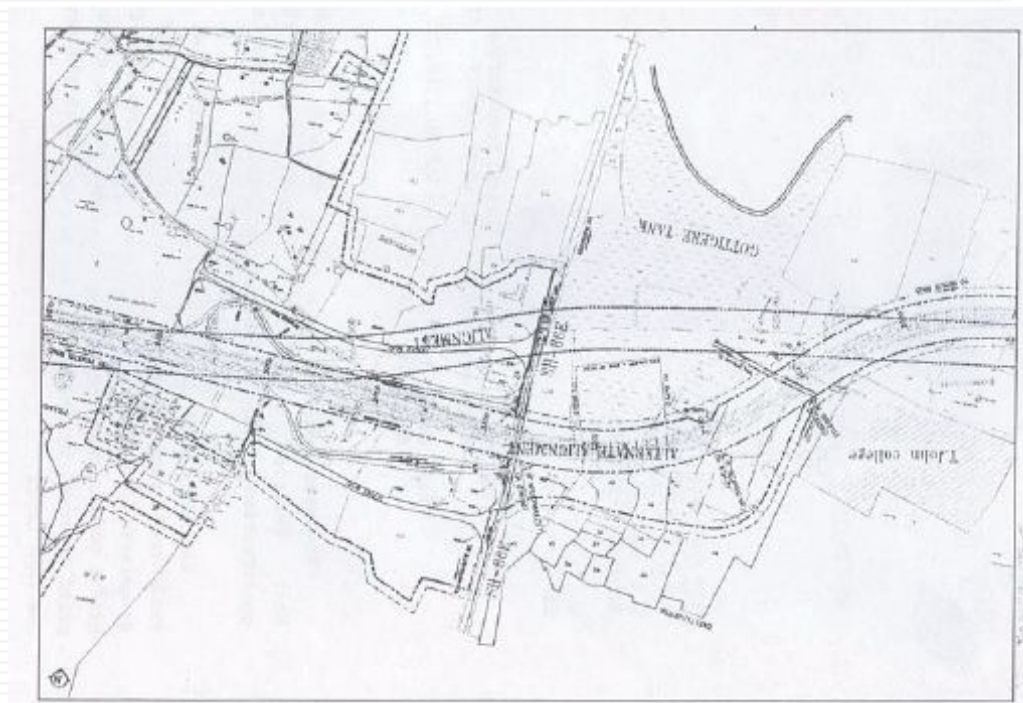
Figure 3 : Proposed Alignment of Expressway at Gottigere

Gottigere lake is under pressure from large scale developmental activities, which is detrimental to its sustenance. Topography in the catchment should not be altered and a large scale land use change has to be banned for the survival of the lake. Storm water drains are to be redesigned to ensure rainwater is channelled into this lake. Efforts should be made to ensure that these tanks are not polluted by the discharge of effluent and industrial wastes. Existing tanks should be deweeded and aquatic life must be developed. Buffer zone (500 m from the shore line) is to be created and maintained to enhance the water yield and hydrology of the waterbody. 500 m across waterbody and valley zones are to be declared "no activity zones". Peripheral ring road either over or adjacent to the tank will alter the ecology and hydrology of the lake and the lake catchment (up to 500 m from shoreline should not be disturbed). Two alternate alignments suggested at Gottigere, part of peripheral ring road is depicted in Figure 3. Alignment 1, passing over the tank covers significant amount of tank's surface blocking the amount of light that penetrates into the waterbody, which can have serious ecological implications (discussed below). On the other hand, the Alignment 2 passes around the tank, taking away some amount of land over the inflow to the tank. This study attempts to bring out the short-comings of both these approaches and highlights likely ecological implications on the tank.

The alignment of PRR over the tank affects the ecology of tank significantly by the obstruction of incident light into the water. This can have serious implications on the biological organisms especially the primary producers, which thrive on sunlight for converting the incident light into energy. Light is the factor that fundamentally determines the level of primary production. In the tank ecosystem primary productivity is controlled by bottom-up factors (nutrient levels) and secondary effects due to biological factors (zooplankton grazing). The light regime experienced by algae is determined largely by mixing of the water column. The processes of photo inhibition and light attenuation combine with the resultant light-dark adaptation to shape the low productivity profile and it eventually ends in affecting the higher organisms in the lake food chain.

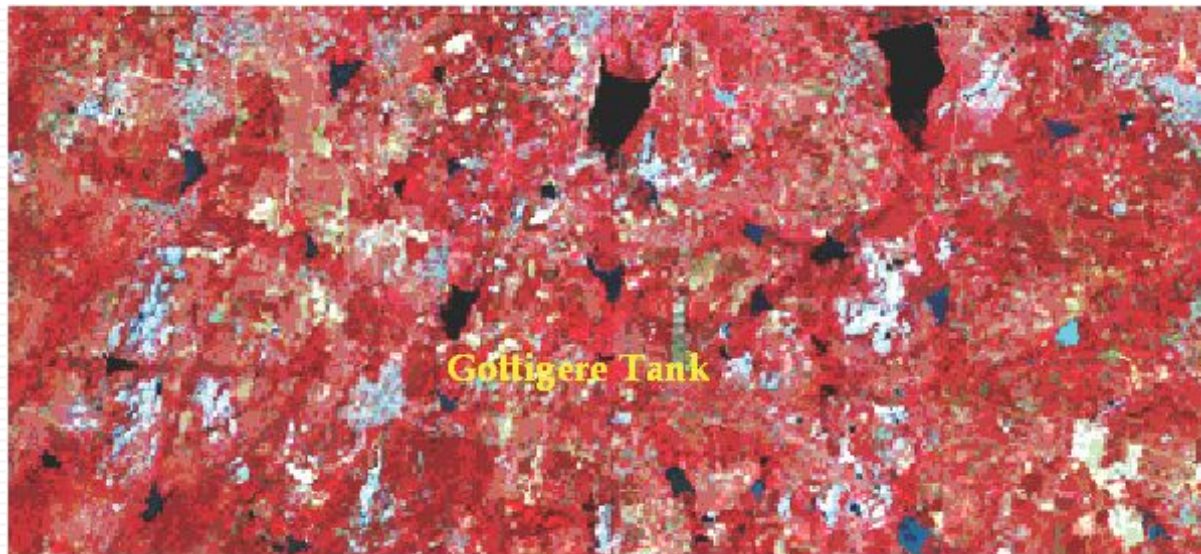
Figure 4: False Colour Composite around Gottigere in 2000

The land use changes already initiated by the alignment of the Peripheral Ring Road (PRR) is analysed based on the satellite remote sensing data for the years 2000 and 2006. The satellite remote sensing data of Landsat ETM+ for 2000 was obtained from Global Land Cover Facility and the LISS-III data for 2006 was obtained from National Remote Sensing Agency, Hyderabad. These data were pre-processed for image geo-registration and rectification. The false colour composites (FCC) for these two time periods were created (Figure 4 and 5) to compare the land use changes through visual interpretation.

Comparative analysis of Figure 4 and Figure 5 shows the land use changes due to the construction of PRR with the increased urban (built-up) pockets in the lake catchment. Creation of ring roads around the city aids as sinks of sprawl thus implicating the change in land use significantly. Owing to poor planning practices and enforcement of the development plans, the feedbacks and implications of such infrastructure projects are not captured. As in the case of most infrastructure development projects that the city has embraced, this is yet another such project which has overlooked certain critical implications on land use and the corresponding implications on the socio-economic aspects of the people directly affected by the project and the ecological implications of the project.
