Present status of Gottigere Tank : Indicator of Decision maker's apathy

Ramachandra T.V , Sudhira H.S.

ENERGY AND WETLANDS RESEARCH GROUP
CENTRE FOR ECOLOGICAL SCIENCES
INDIAN INSTITUTE OF SCIENCE
BANGALORE 560 012

ENVIS Technical Report : 26

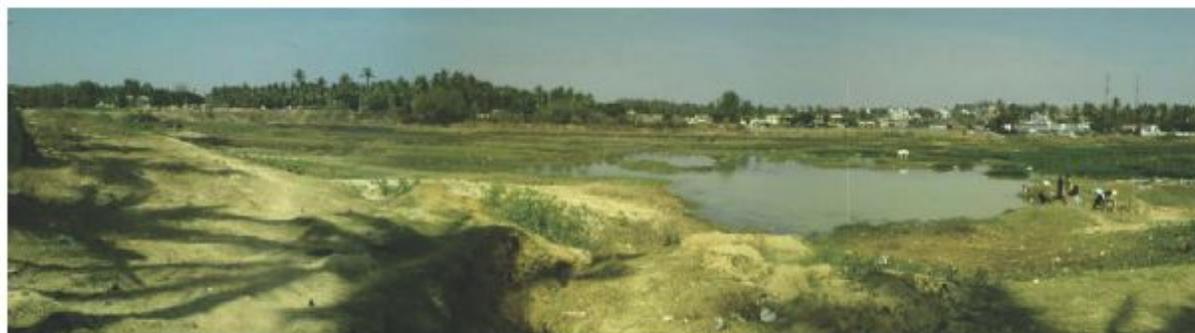
Figure 1: Panoramic View of Gottigere Tank

The Gottigere tank is part of the South Pennar river basin and is an important feeder tank to the Hulimavu and Madiwala tanks, which eventually feed to Bellandur and Varthur tanks. It has a water-spread area of 14.98 Ha. The location of the tank in the Bellandur tank series is depicted in Figure 1 and Figure 2, which gives a panoramic overview of the tank and the tank in Bellandur watershed. The rainfall data for the region is available for the last 100 to 110 years. Rainfall varies from 725.5 mm to 844.8 mm. The district receives 51 % of the total annual rainfall in the southwest monsoon period, i.e. June to September. The average annual rainfall in the catchment was 859 mm in 1999. April is usually the hottest month with the mean daily maximum and minimum temperature of 33.4° C and 21.2° C respectively. December is generally the coolest month with the mean daily maximum and minimum temperature of 25° C and 15.3° C respectively. The temperature drops down to 8° C during January nights. Relative humidity is high from June to October (80 to 85 %). Thereafter, it decreases and from February to April becomes 25 to 35%. The relative humidity in the morning is higher than in the evening, giving rise to the formation of fog.

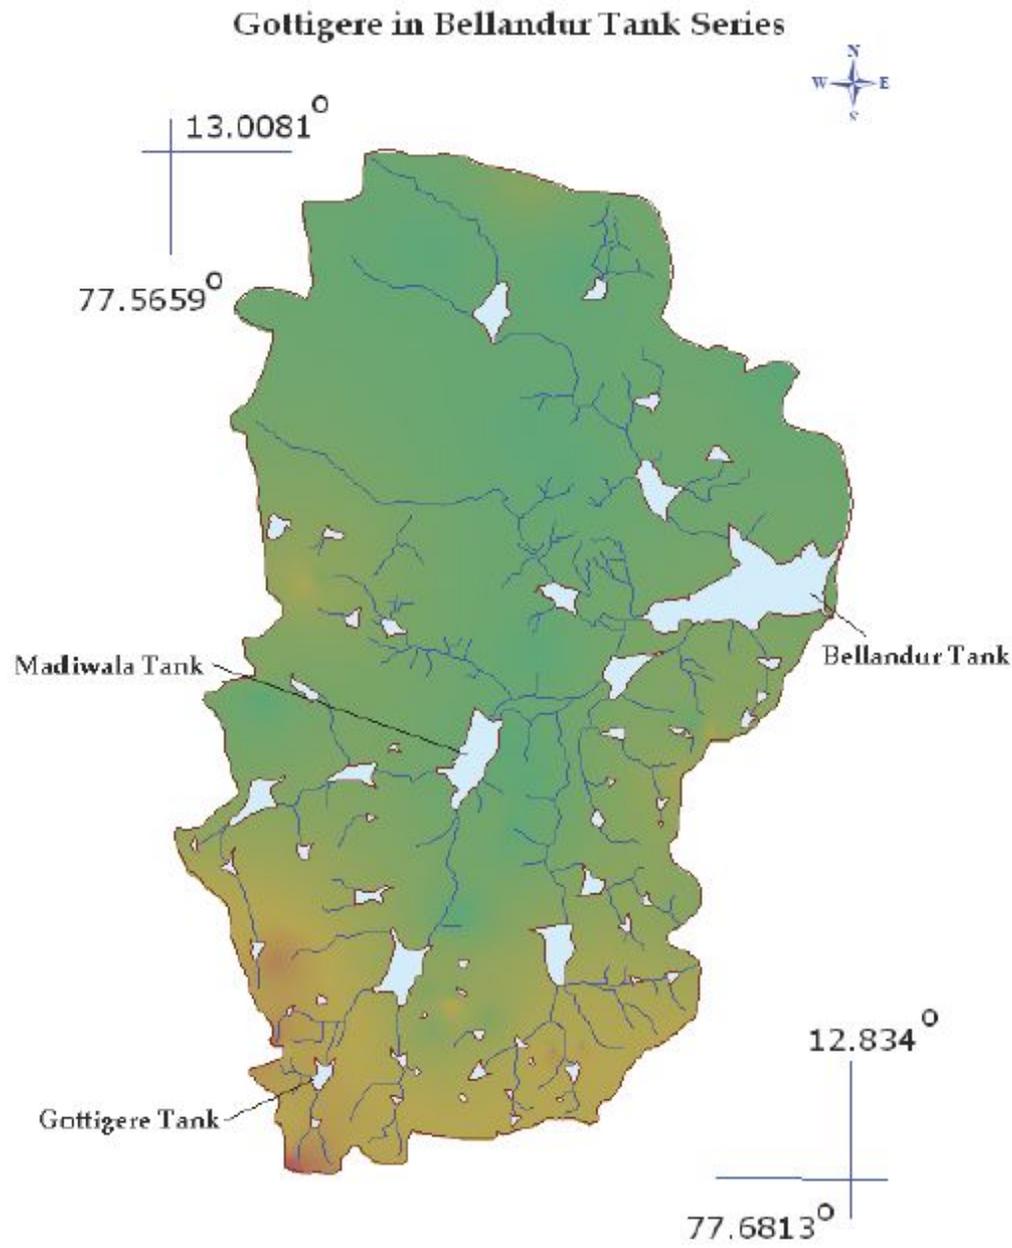
Figure 2: Gottigere Tank in Bellandur Tank Series

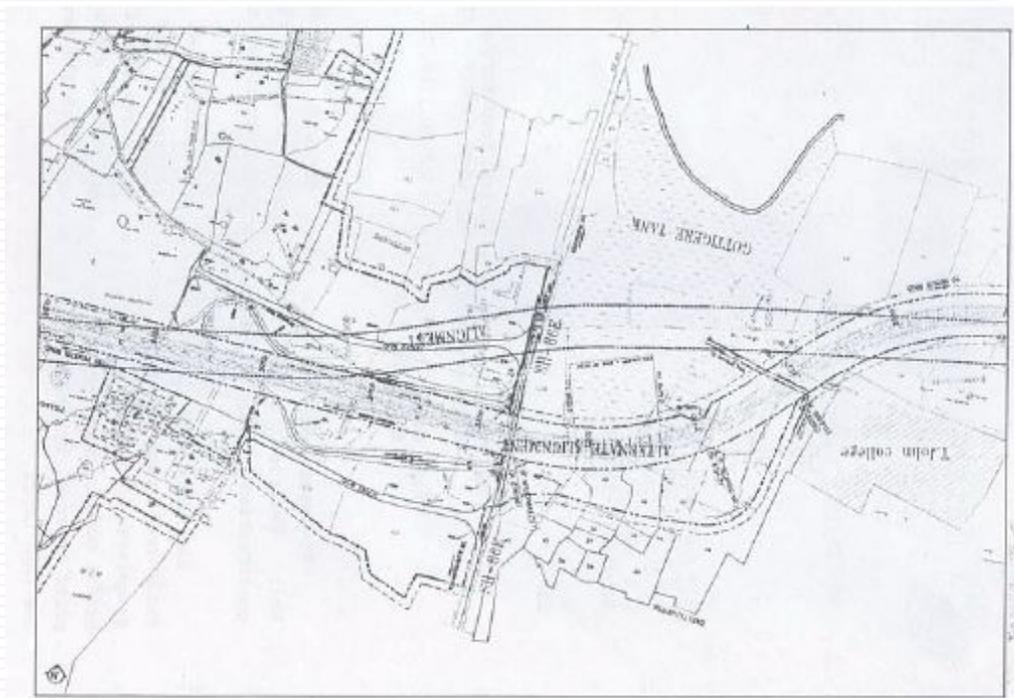
Figure 3 : Proposed Alignment of Expressway at Gottigere

The alignment of PRR over the tank affects the ecology of tank significantly by the obstruction of incident light into the water. This can have serious implications on the biological organisms especially the primary producers, which thrive on sunlight for converting the incident light into energy. Light is the factor that fundamentally determines the level of primary production. In the tank ecosystem primary productivity is controlled by bottom-up factors (nutrient levels) and secondary effects due to biological factors (zooplankton grazing). The light regime experienced by algae is determined largely by mixing of the water column. The processes of photo inhibition and light attenuation combine with the resultant light-dark adaptation to shape the low productivity profile and it eventually ends in affecting the higher organisms in the lake food chain.

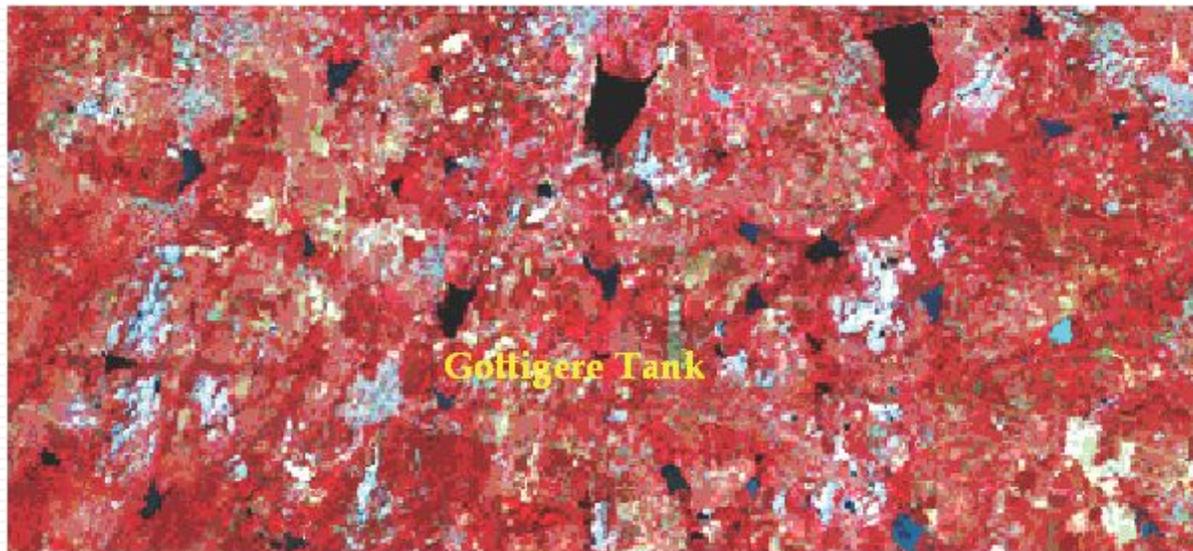
Figure 4: False Colour Composite around Gottigere in 2000

The land use changes already initiated by the alignment of the Peripheral Ring Road (PRR) is analysed based on the satellite remote sensing data for the years 2000 and 2006. The satellite remote sensing data of Landsat ETM+ for 2000 was obtained from Global Land Cover Facility and the LISS-III data for 2006 was obtained from National Remote Sensing Agency, Hyderabad. These data were pre-processed for image geo-registration and rectification. The false colour composites (FCC) for these two time periods were created (Figure 4 and 5) to compare the land use changes through visual interpretation.

Comparative analysis of Figure 4 and Figure 5 shows the land use changes due to the construction of PRR with the increased urban (built-up) pockets in the lake catchment. Creation of ring roads around the city aids as sinks of sprawl thus implicating the change in land use significantly. Owing to poor planning practices and enforcement of the development plans, the feedbacks and implications of such infrastructure projects are not captured. As in the case of most infrastructure development projects that the city has embraced, this is yet another such project which has overlooked certain critical implications on land use and the corresponding implications on the socio-economic aspects of the people directly affected by the project and the ecological implications of the project.

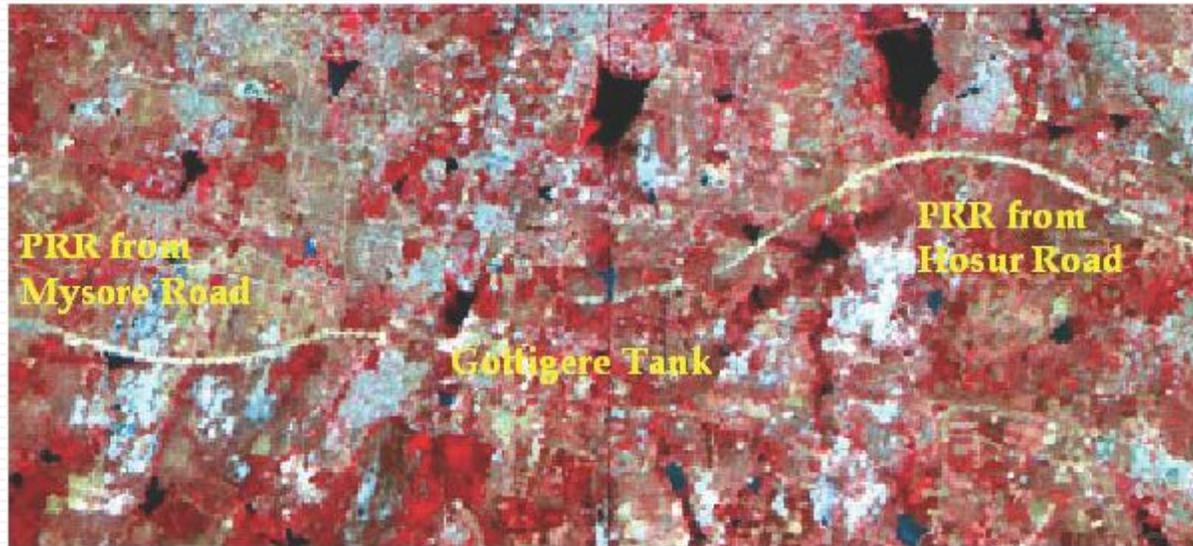
Figure 5: False Colour Composite around Gottigere in 2006
